**WATER DAMAGE TO
ASPHALT OVERLAYS:
CASE HISTORIES**

**Prithvi S. Kandhal
Carl W. Lubold, Jr.
Freddy L. Roberts**

**Presented at the Annual Meeting of the Association of Asphalt
Paving Technologists in Nashville, Tennessee, February 20-22, 1989.**

NCAT Report No. 89-1

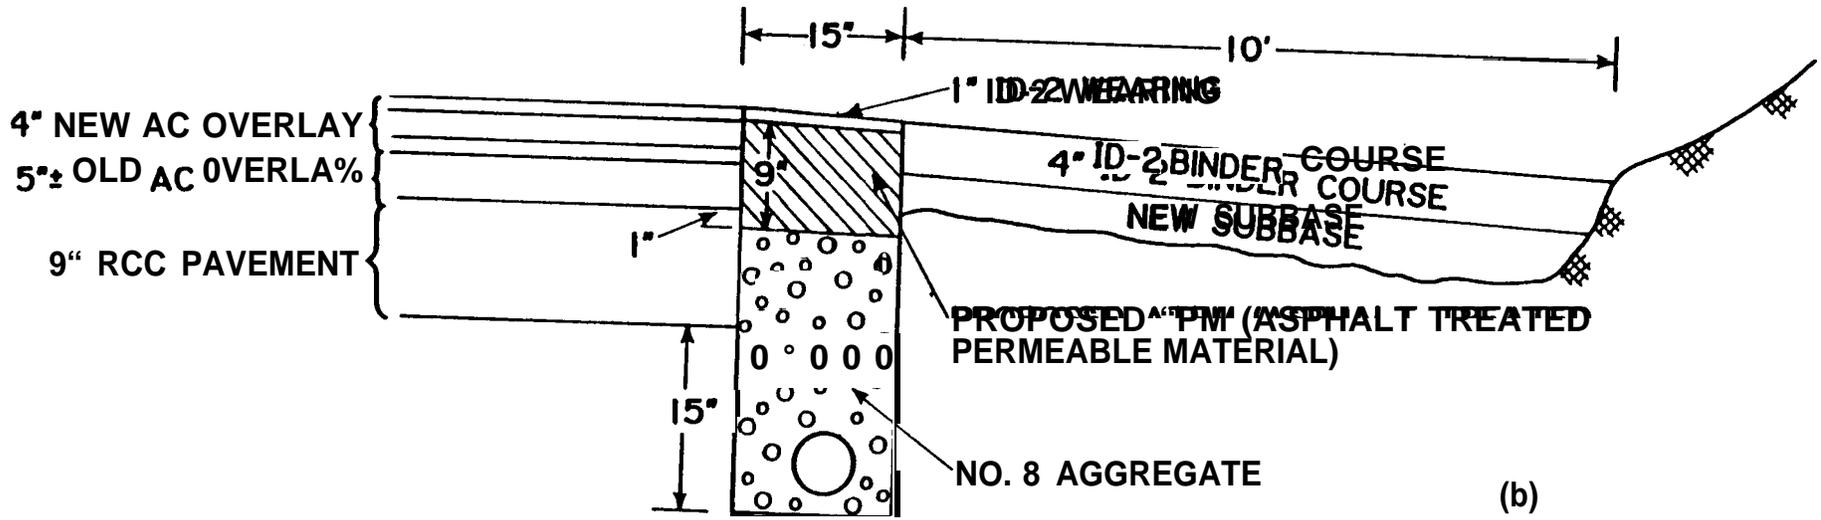
¹ Drainage of pavement layers blocked at the pavement edge by the binder course in the shoulder (Figure 2a). No. 8 stone was wet below the bottom line of PCC pavement, whereas, dry to damp above this line.

FIG. 2. EAST-WEST TURNPIKE TYPICAL CUT SECTION
 (a) EXISTING (b) PROPOSED

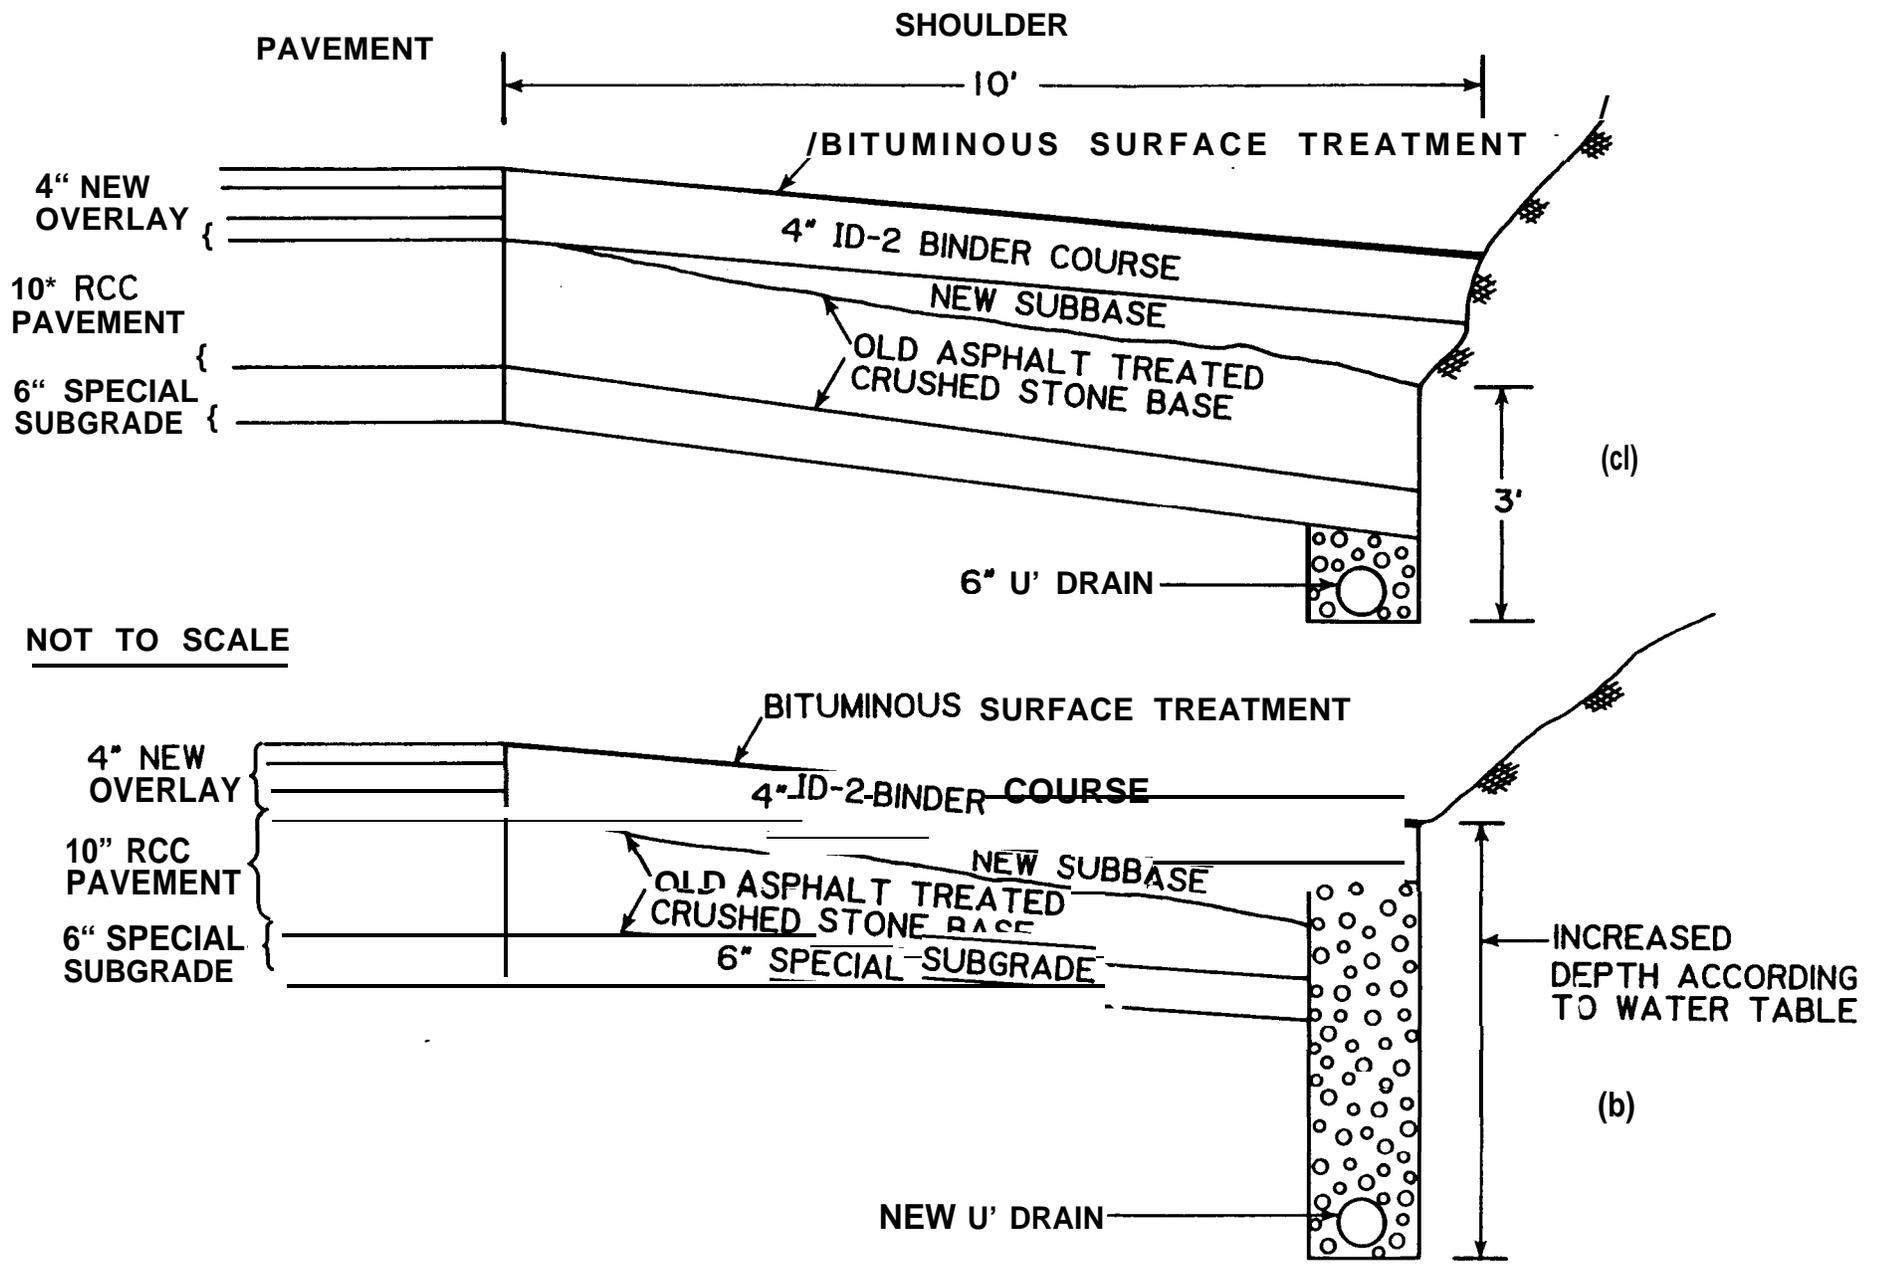
disintegrated portions of the PCC pavement. Since the two longitudinal underdrains are only 3 feet deep and are spaced 70 feet apart at the shoulder edges in tangent cut sections; their effectiveness in lowering the water table (especially in the middle of the roadway) and draining the subgrade is questionable (Figure 16). This lack of effectiveness was confirmed by observations in cut areas where the pavement layers were wetter near the concrete median than in the area near the center line. Most of this North-East Extension section is mountainous and is predominantly built in cut sections.

FIG. 16. NORTH-EAST TURNPIKE TYPICAL CUT SECTION
 (a) EXISTING (b) PROPOSED

The subsurface drainage should be improved by increasing the depth of the two longitudinal underdrains at the shoulder edge in cut areas. The proposed improvement, as shown in Figure 16b, will also drain the new shoulder subbase, which is sandwiched between two impermeable layers and is causing asphalt stripping in the overlying new binder course.
